Navajo Abandoned Uranium Mine

Site Screen Report

Max Johnson No. 7 AUM Site

Weston Solutions, Inc.

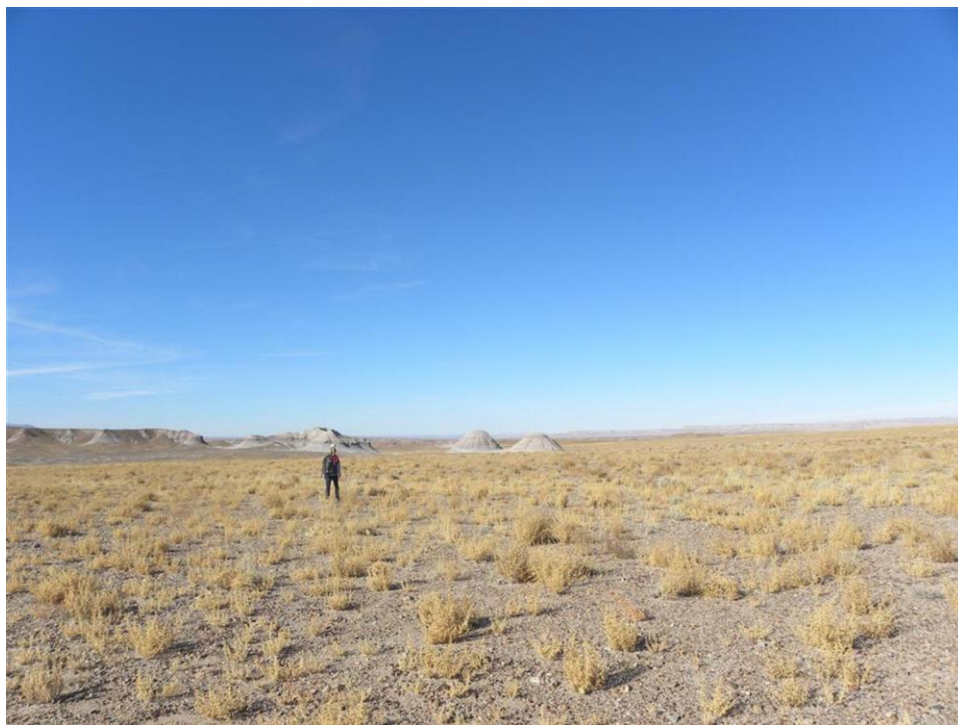
Photo 1. Max Johnson No. 7 mine site

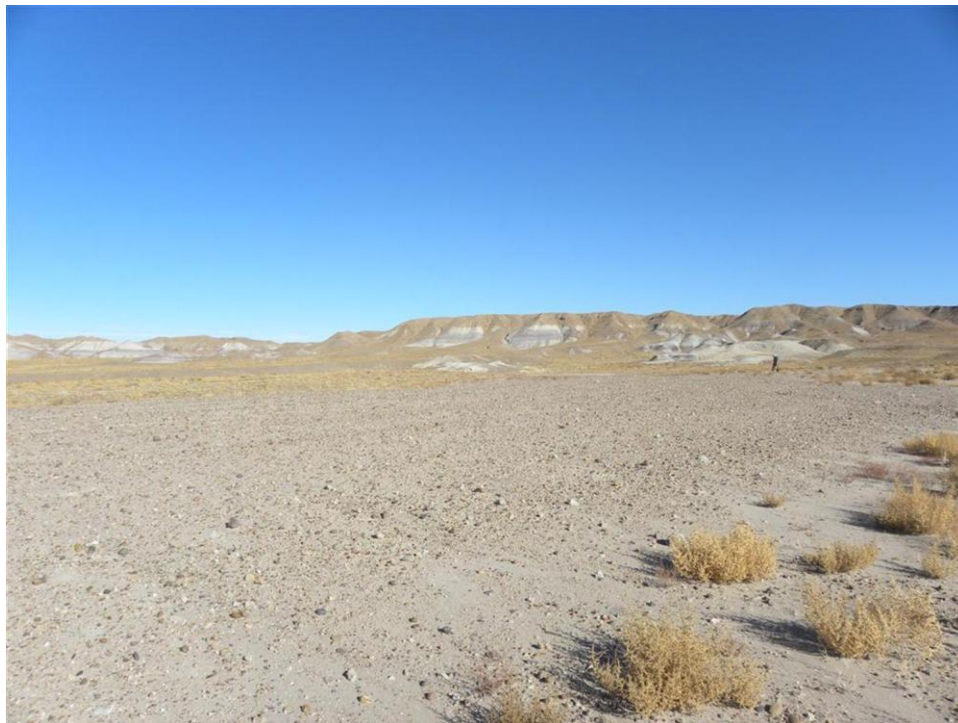
Reclamation cap in center of site, 75' x 250 ', flat

Photo 2. Max Johnson No. 7 mine site, reclamation cap

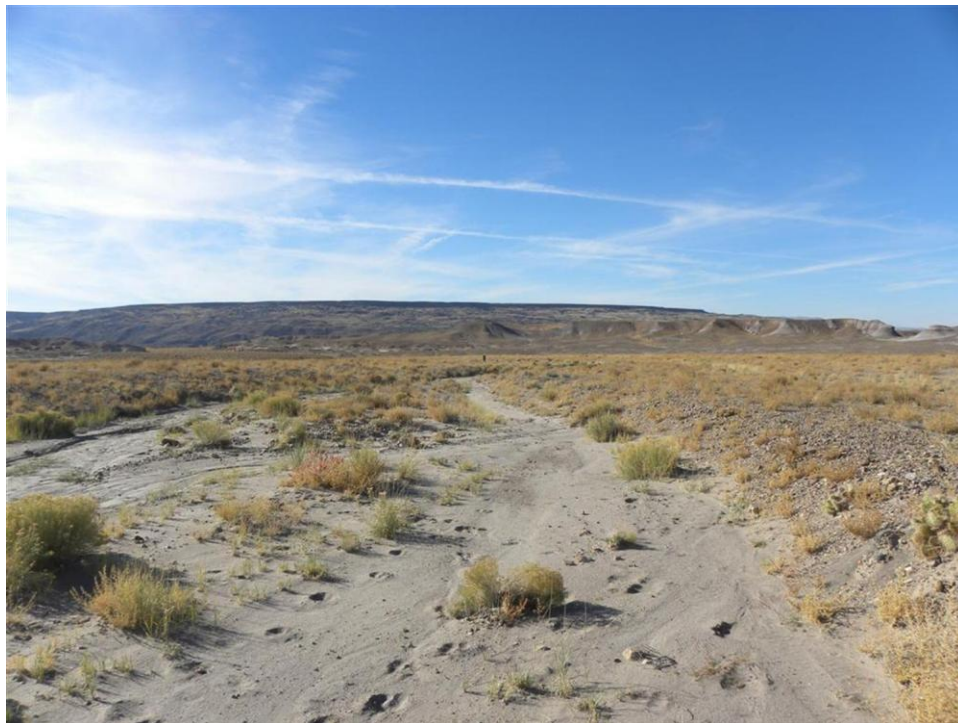
Photo 3. Max Johnson No. 7 mine site, drainage running site
